# PILED RIVER

THE OFFICIAL PUBLICATION OF THE PILE DRIVING CONTRACTORS ASSOCIATION | SUMMER 2003 VOL. 4, NO. 3

# Pine Hills Sinkhole Project:

## A True Collaborative Team Effort

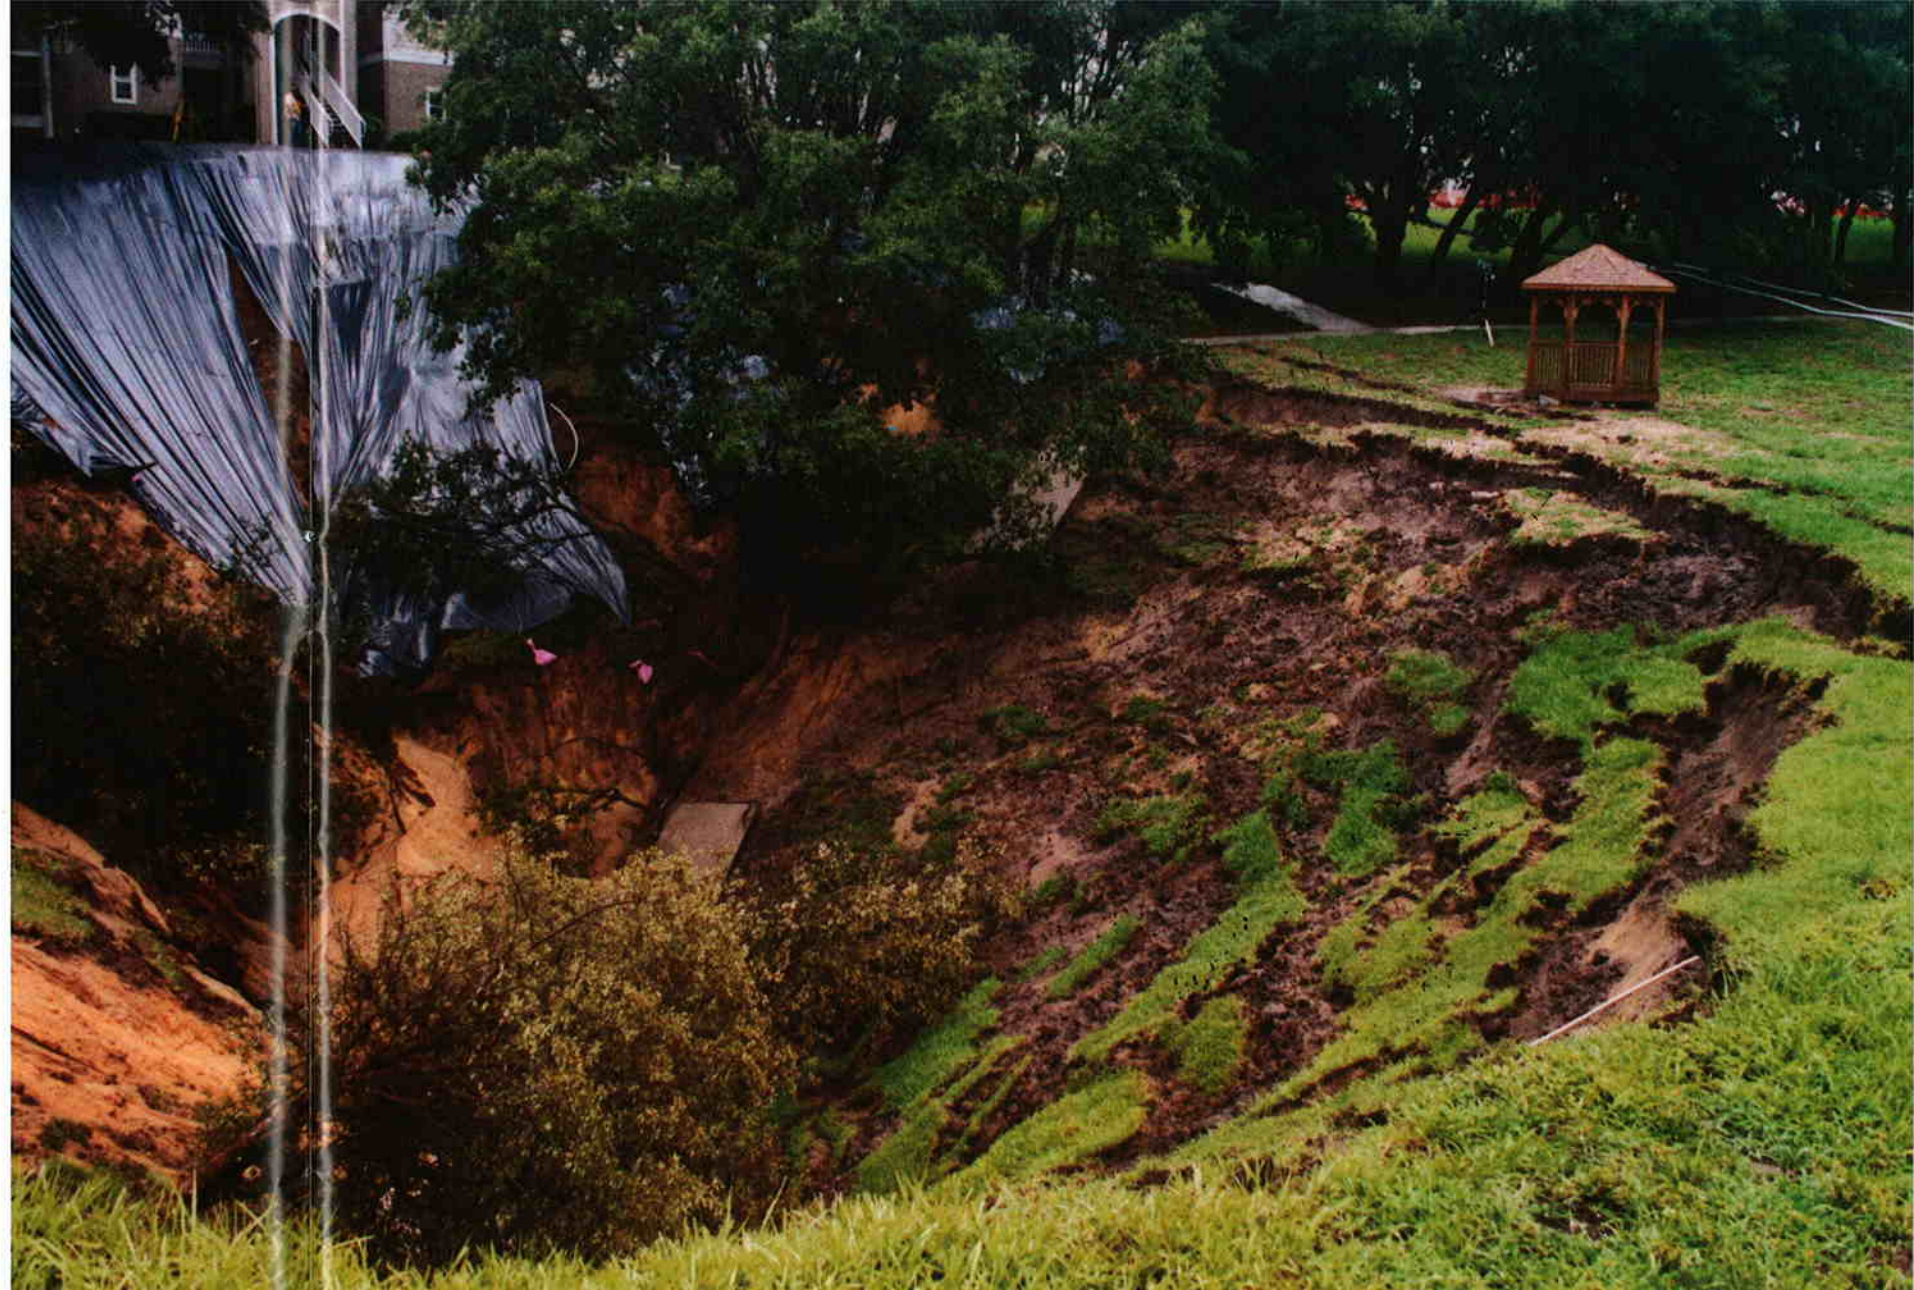
The Pine Hills sinkhole first occurred on June 11, 2002 around 5 pm. Two hours later the ground had fallen to create a crater the size of half a football field.

Capturing national attention, the sinkhole, which occurred on June 11, 2002 around 5:00 p.m. at the Woodhill Apts. in Pine Hills, just west of Orlando, created a cavity 150 ft. wide by 60 ft. deep and was situated only 10 ft. away from a two-story apartment buildings and its residents.

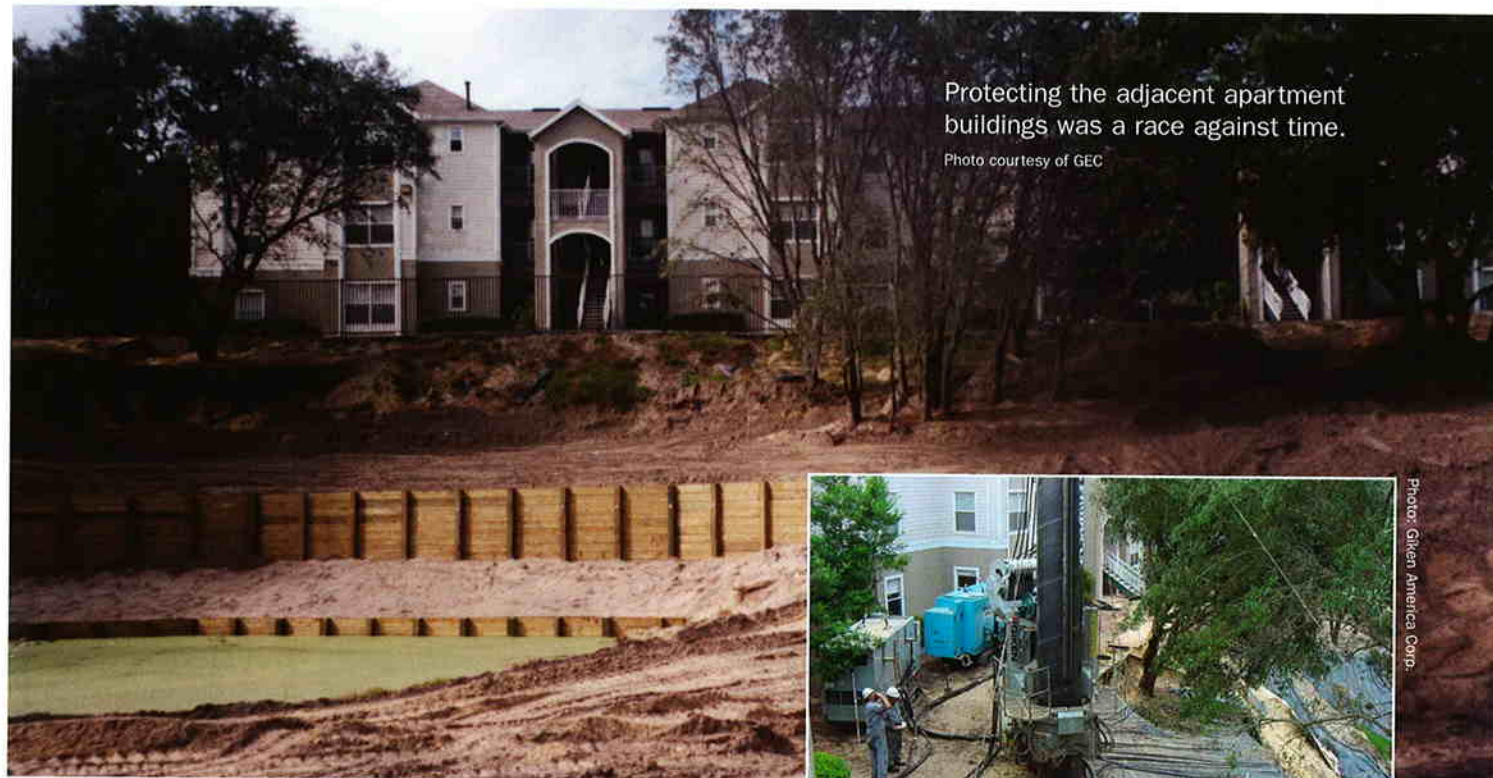
Protecting the adjacent apartment buildings was a race against time.

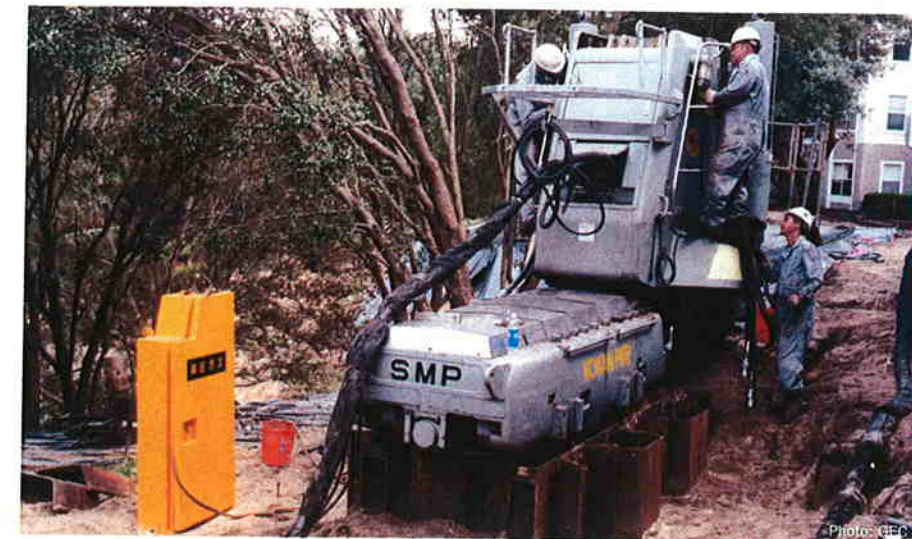
In the end, Giken was successful in completing the wall on July 11, 30 days after the sinkhole first appeared. The apartments were saved without any structural damage. Minor settlement caused some cosmetic cracking that was easily repaired. Apartment residents were able to move back into their homes.

Says Giken America's Santos: "This is the first time in the company's history that our system was used for a "rescue" emergency project. We are proud that

we performed our job without incident or injury considering the tight confined spaces and inability to see the crane operations."

Giken America Corporation, a specialty foundation contractor, installed a unique 200-ft. linear wall of 50-ft. deep interlocking pipe piles between the apartments and the sinkhole using an unconventional method of pressing piles.

"This strategic wall had to be installed quickly and without disrupting fragile foundation conditions. The pipe piles had to be lifted over the tops of the apartment buildings to the sinkhole using a 300-ton [Demag] crane," continues Kuhns. The crane was rented from Beyel Brothers Crane and Rigging in West Palm Beach, specifically for this project.
